## Evaluation of the San Jacinto Waste Pits Cap Defect

June 2016

Letter Report

Prepared for      U.S. EPA, Region 6  
Dallas, TX 75202

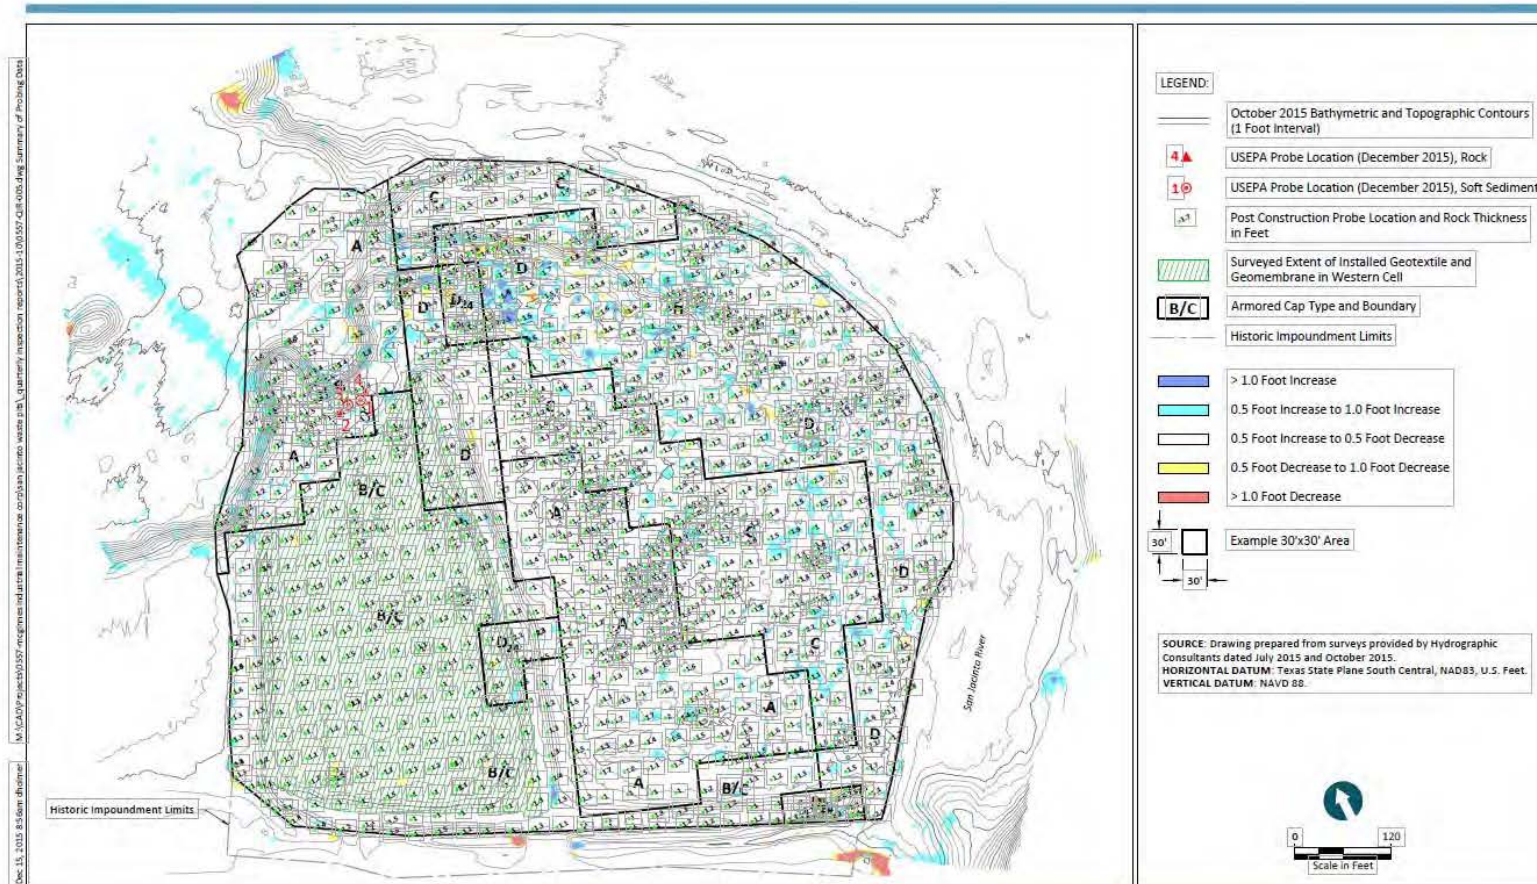
Figure 3. Summary of Probing Data Post TCRA Inspection.

Other activities included the probing and repair of the deficiency by placing a non-woven geotextile in the location of the deficiency (Figures 3, 4, and 5) and placing armor stone over the textile to achieve the required depth of armor.

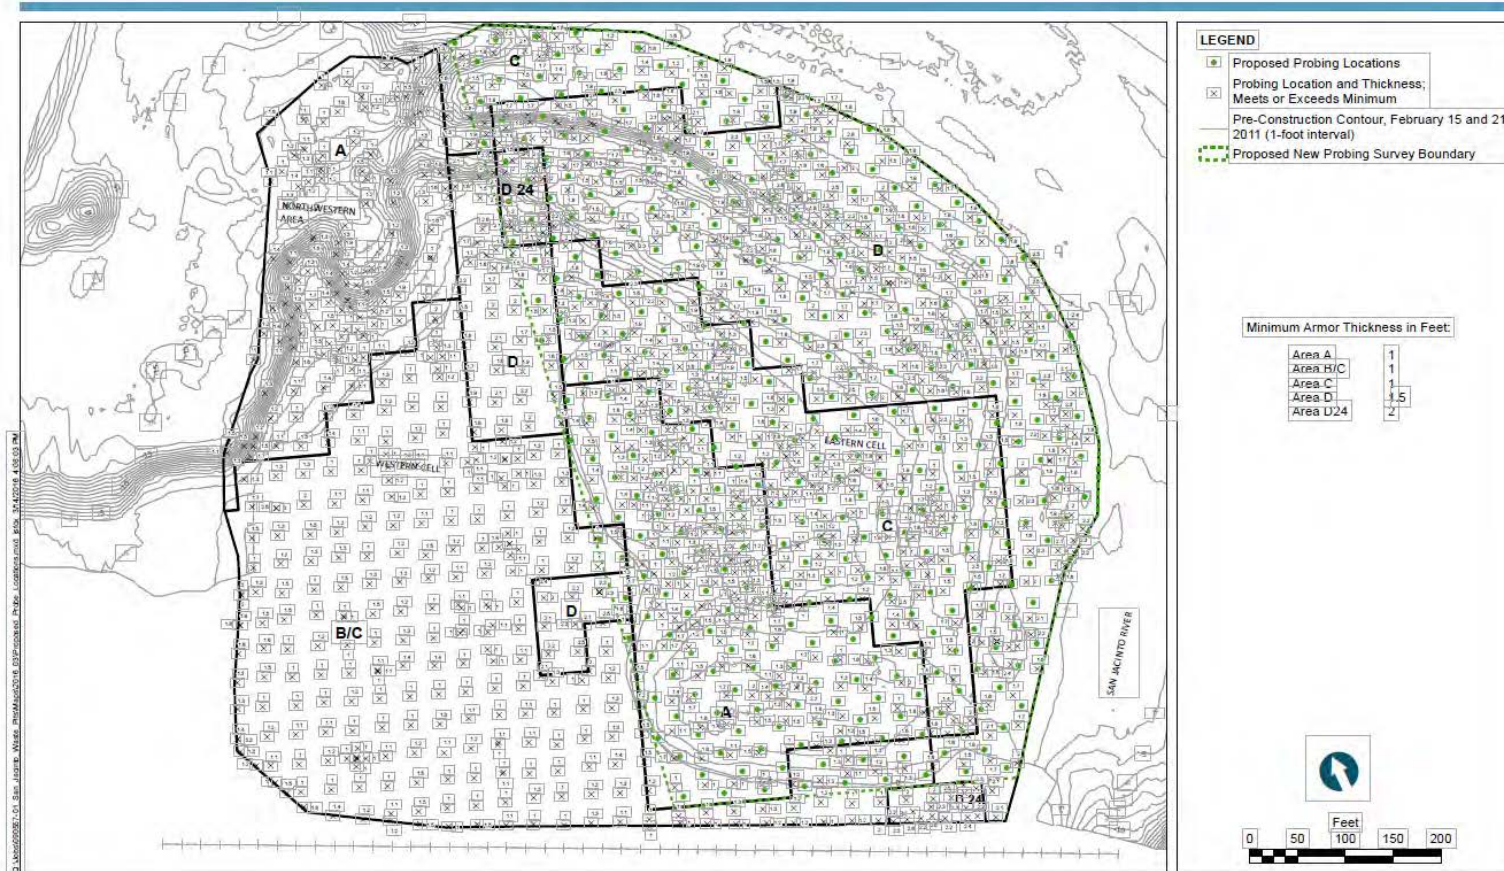
Figure 6. Proposed Supplemental Probing.

been significant ground truthing of the bathymetric data against actual deficiencies. The probing done by the EPA team, the proposed supplemental probing (Figure 6) and the results of those inspections increase the confidence of the integrity of the cap. The surveys, though useful, have not shown the reliability of the probing; the problem with the probing is the lack of coverage of the site. To build the confidence of the cap integrity, more than ninety-five percent of the cap that is probed should be without defects. The results from the Eastern Cell were 12 deficiencies in four hundred probes; that is around ninety seven percent (97%) without significant defect, suggesting that defects are outliers of limited size.

Recommendations include supplemental probing like the one performed in the Eastern Cell; the goal is to reduce the number of deficiencies. Probing should continue to the Western Cell with the same density as what was performed in the Eastern Cell (200-250), and the finally to the Northwestern Area. Here is where it gets trickier; this area requires the greatest density of manual probing since it is the steepest and does not have a geotextile or geomembrane. Manual probing in the order of 300-400 is not out of the question based on the potential for deficiencies in this area due to construction and post-construction conditions.

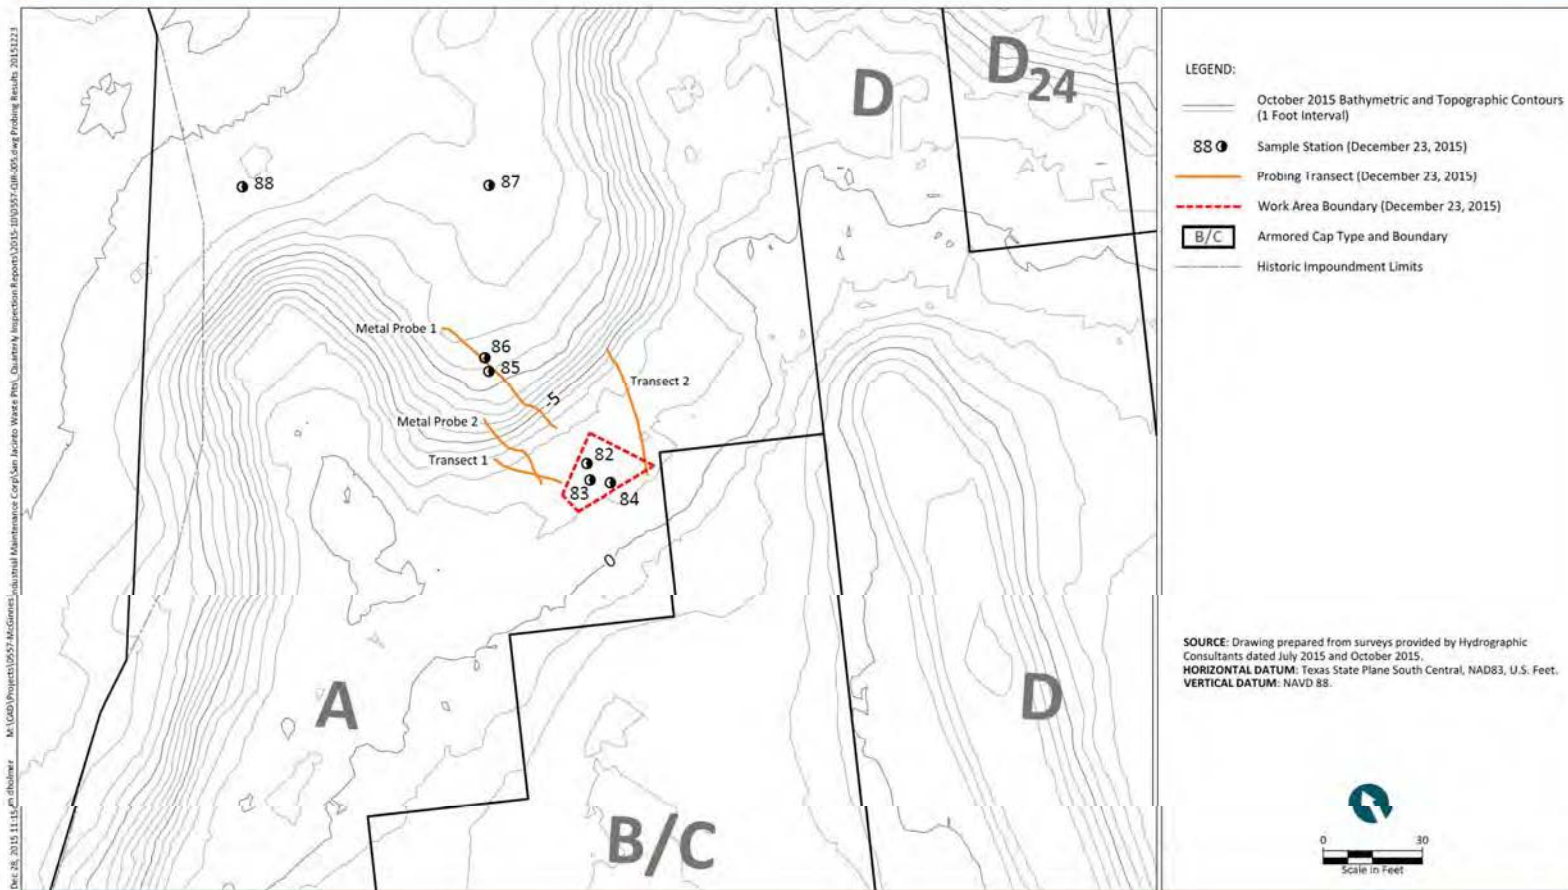
Figure 8. Probing and Sample Collection as part of Maintenance and Repair of the Deficiency Area of the SJRWP Armor Cap.

Figure 8 shows the probing transects and samples collected as part of the assessment of the cap deficiency in December 2015. Figures 9 and 10 show the level of contaminant in the three sediment samples collected from the cap deficiency. Figure 9 is from the exposed sediment, the sample was split with EPA and documented in the report 05\_San Jacinto RIFS OS Data Validation for December 2015 Split Sampling, a letter report.

The levels of the three samples collected from within the cap deficiency zone vary significantly; two are around 40,000 ng/kg and one is nearly an order of magnitude less (8180 ng/kg).

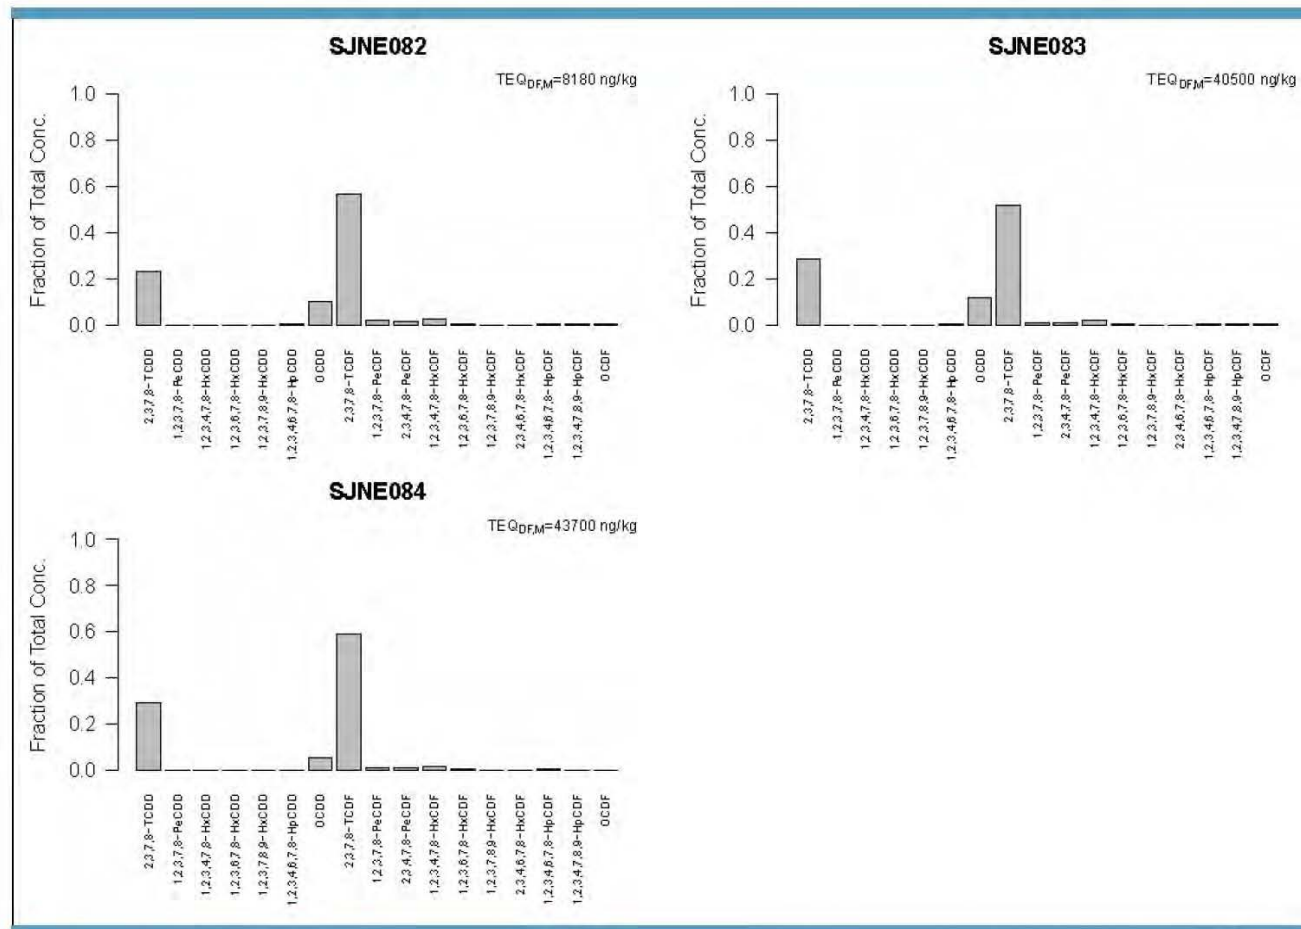
Figure 9. Dioxin and Furan Fingerprints for 2015 Sediment Samples Collected from Within the Delineated Area.

The levels of the two samples (SJNE085 and SJNE 086) from the northwest toe of the cap's sloped area near the cap deficiency area are shown in Figure 9. The levels are 500 times lower than the two highest values at the impacted zone and 100 times lower than the lowest value from the impacted zone.

Comparison of Figure 12 with Figures 9 and 10 shows that the fingerprint from the sediments collected in the deficient area is close to the EM2 model, while the data from the sites outside the exposed area follow the EM1 model. If sediment from the deficient area was released the impacted sites would exhibit a form of the EM2 model (fingerprint), one can say that there is a slight contribution by the short peak of TCDF, so most of the sediment from the toe and outside areas receive most of the loadings from other areas beside the SJRWP. In addition, the samples from the deficient area show evidence of deposition of sediment from outside the SJRWP due to presence of higher distribution of OCDD than in the EM2 model. The presence of deposition in the deficient area would indicate the long-term presence of the defect, the stability of sediment at the defect, and no significant release of contaminants from the deficient area.

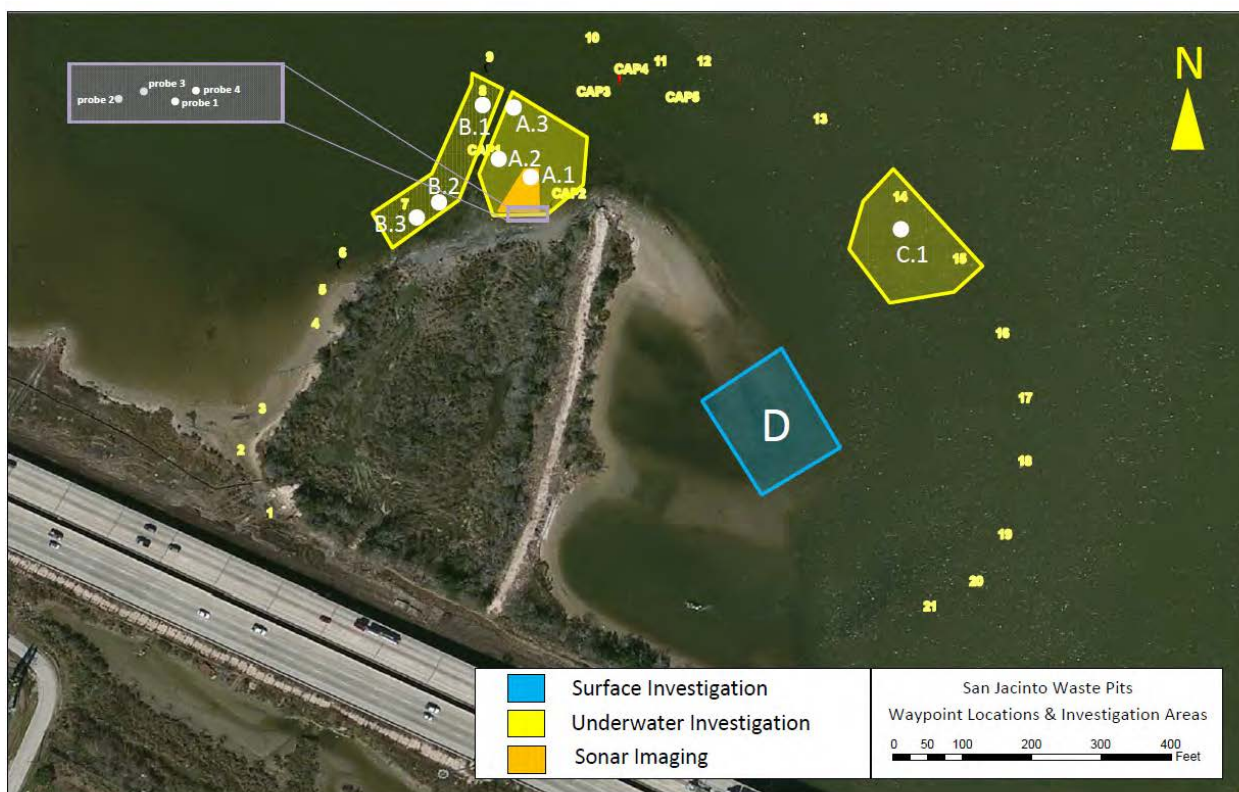
**Figure A1. Site investigation area.**

Figure A1 shows the area where the EPA dive team found the deficiency area. Figures A2-A5 shows the site from different angles and views. All the pictures show that there is a ridge, mostly the berm of the original impoundment that is higher than the deficient area (elevation of the rocks); in particular Figure A4 and A5. Figure A5, the area after repairs; show that the only possible strike would have to occur between the two rock ridges, since neither ridge shows any impact. Figure A6 shows the ridges around the deficient area from the northeast view; no impact on the rocks on either side of the impacted area can be observed. Figure A7 shows the impacted area delineated after the probing.

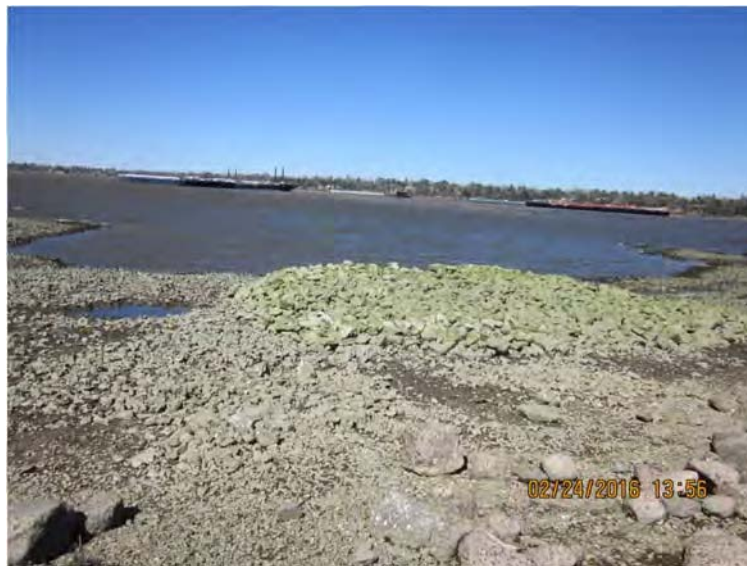
**Figure A5. Site investigation/maintenance area after repairs.**

ridge/rocks on that area do not show any impact or disturbance (see Figures A5 and A6).

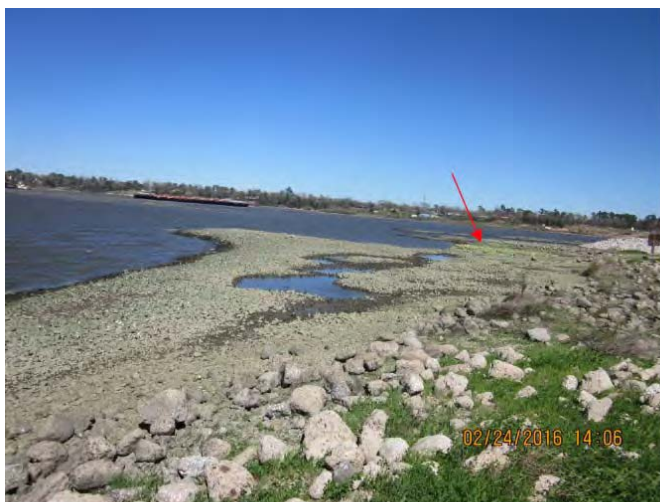
**Figure A6. Northeast view of the site investigation/maintenance area after repairs.**

Northern edge of Western Cell (view northeast). December maintenance area marked with arrow.

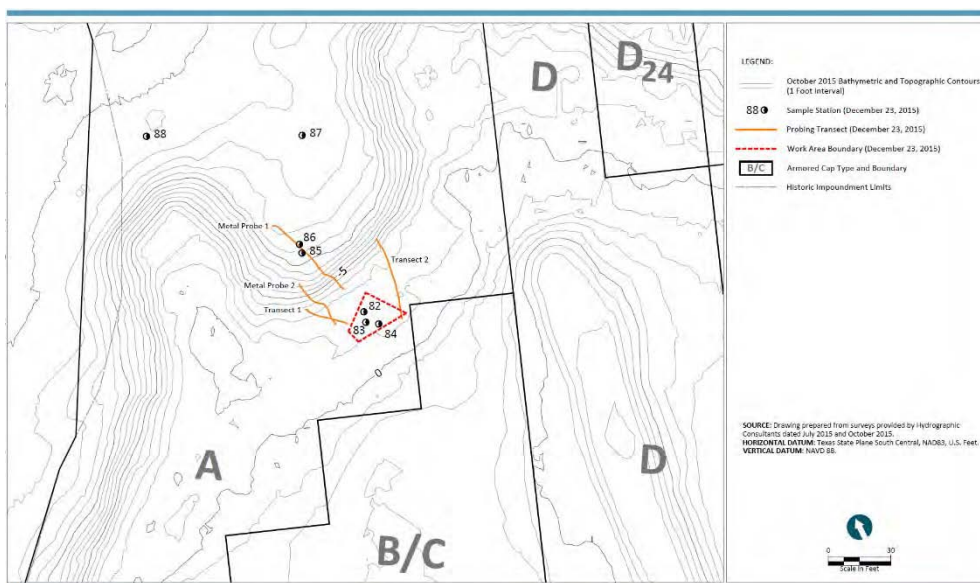
**Figure A7. Work area boundaries and sample collection.**

Looking at the area of impact/deficiency as delineated in Figure A7 shows that angle of impact from a barge/tug strike should have occurred from the northwest (where sample 82 was collected, toward sample 83, see Figure A8). That follows the wedge that a tug would have created. The difficulty with that strike is that there is a ridge on that side of the deficient area as shown in Figures A2-A6, and that

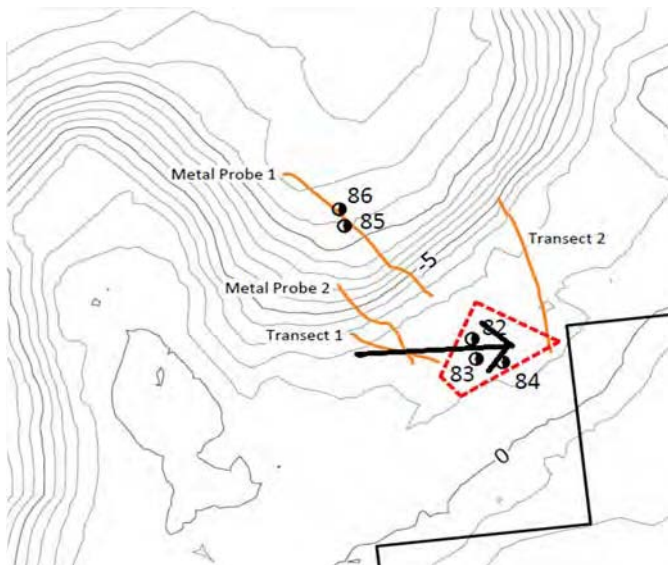
**Figure A9. Second strike direction.**

The other potential strike as shown in Figure A9 is from the west side, again the ridge/rocks on that side (see Figures A5 and A6) show no disturbance.

So based on the angles, the lack of impact around the surrounding areas where the approach would have occurred, and the lack of depression in the deficiency area we can say that a barge/tug strike was very unlikely.

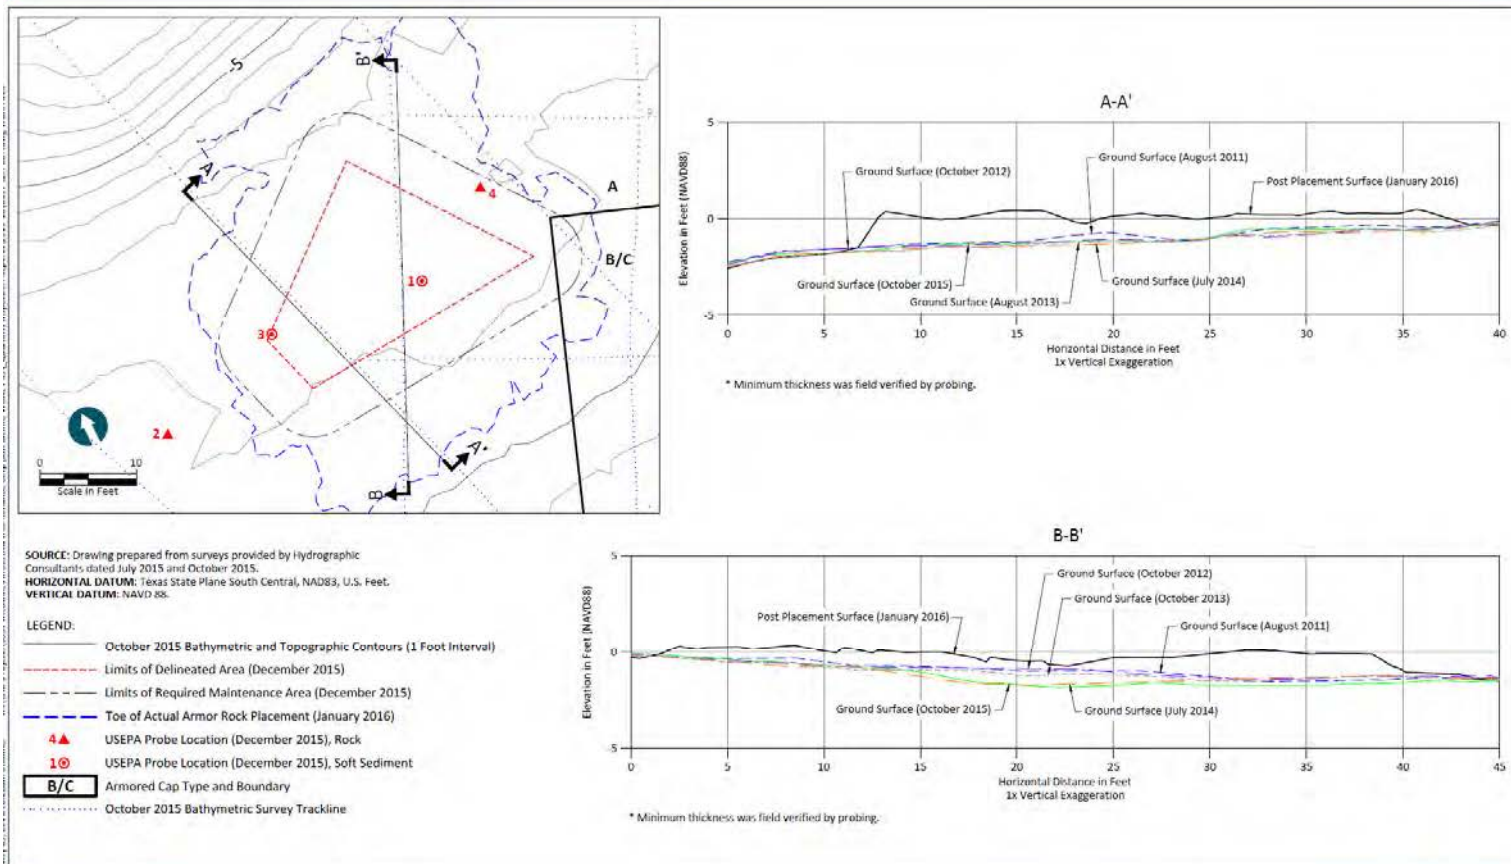
**Figure B1. Bathymetric and topographic surveys for the defect area.**

Appendix B shows that the area of the defect has been changing in elevation since at least 2013 and maybe even 2012. The discussion in Appendix B was after communication with the repair team and there wiliness to provide us with ground surveys for the deficient area for the last six years. The data leads us to belief that the defect area was caused by sinking of the cap over time due to either improper filter/support layer under the rock cap or unusual decomposition of organic matter under the area.

Figure B1 shows the area where the EPA dive team found the deficiency area and was later repaired. The Figure also shows ground surveys from 2011 till 2015, an eastern transect A-A and a northwestern transect B-B, and the probing locations that defined the defect area. The B-B transect clearly shows that part of the defect area was showing a dip in elevation or subsidence since 2013 and maybe even 2012. Figure B2 shows the elevations for transect B-B in more detail; the subsidence starts in 2013 (at least two inches as compared to 2012) by 2014 the subsidence is at least 8-12 inches. The fact that we see a gradual loss or dip in elevation points to subsidence rather than impact. The cause of the subsidence is probably due to lack of support of the larger rocks in the upper cap layer. This area does not have a geotextile under the cap, so if the filter layer under the cap was not properly placed or if the mud underneath exhibit decay or uneven consolidation, then the rocks would begin to sink causing subsidence of the area. In the future it would be very useful to collect bathymetry and ground surveys prior to repairing the cap due to either scheduled maintenance or probing. The collected bathymetry or surveys would be extremely useful in understanding the cause of an event that resulted in a repair or assessment.
